## MINE SITE VISIT REPORT New Mexico AML Program

Mine/Project Name: Beacon Hill Mine – Northwest of Grants, New Mexico

Purpose of Visit: Maintenance inspection to the Beacon Hill mine, part of the legacy site

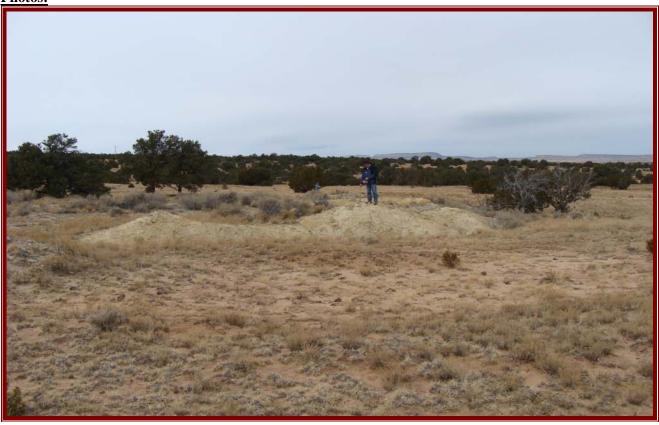
This site has areas of mounded waste, metal mining debris, assorted trash and some pottery shards. There is a drainage running along the east side of this site. For complete details see topographic GPS info using the MapGuide map found at <a href="http://164.64.103.6/mmdtest/AML">http://164.64.103.6/mmdtest/AML</a> Uranium-DEV.htm

Waste Piles Looking Northeast

Further action recommended to mitigate radiometric levels. Scattered drill holes need to be closed.

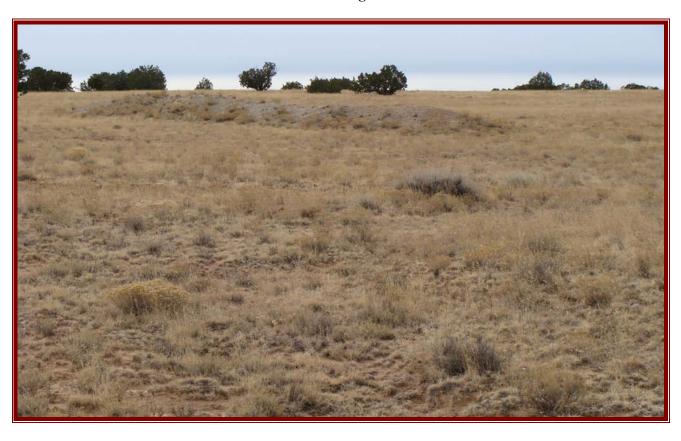
Background radiometric levels of 17  $\mu$ R/hr at 1-meter and surface, were read utilizing a Ludlum Model-14C survey meter with a NaI Model 44-2 Gamma Scintillator probe. The overall waste and ground within the middle portion of the disturbance area have radiometric levels of 269-286  $\mu$ R/hr at 1-meter and 286-457  $\mu$ R/hr at ground level. There was waste found outside the site proper that had radiometric levels of 429  $\mu$ R/hr at 1-meter and 1257  $\mu$ R/hr at ground level.

High Radiometric Level Waste Pile Looking Southwest

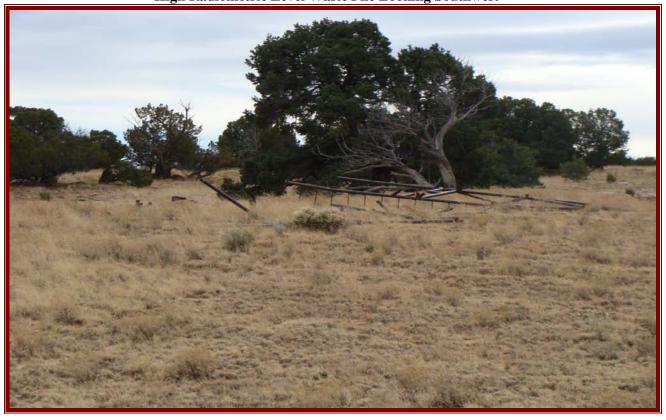
**Collapsed Head Frame Looking South**

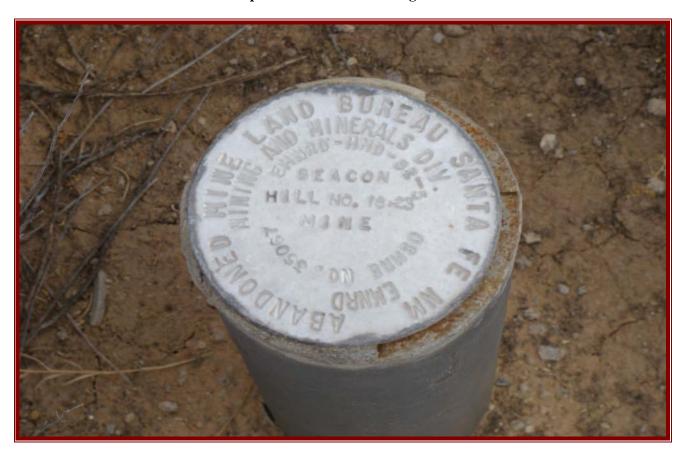
## AML Survey Marker Looking Down
